JENKINS ENGINEERING, INC.

Reference: FINAL REPORT
Building Structural Evaluation
George Walker Natatorium
Delta State University – Cleveland Campus
JEI Job No: 2011-229

**RE: FORENSIC SUBSURFACE EXPLORATION
 DELTA STATE NATATORIUM
 CLEVELAND, MISSISSIPPI**

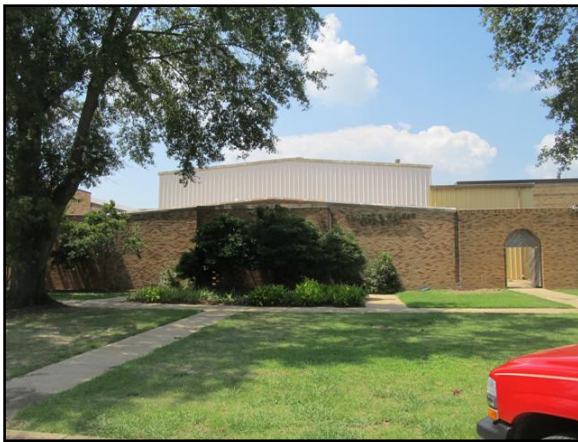
FIGURE 1

Figure 1 shows the front of the 1969 natatorium structure (white siding), the 1985 addition (yellow siding), and the front dressing room enclosure. Figure 2 shows the front of the addition constructed on the north side of the original natatorium.

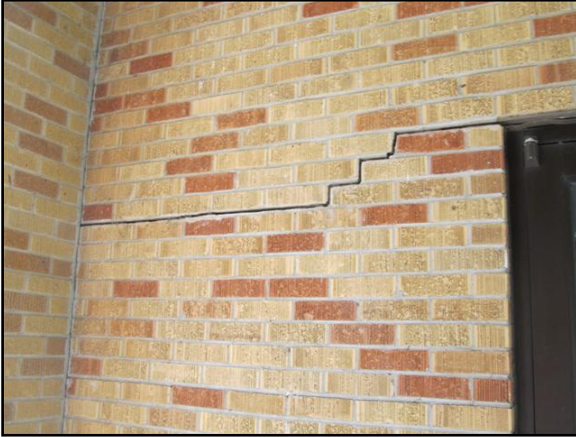
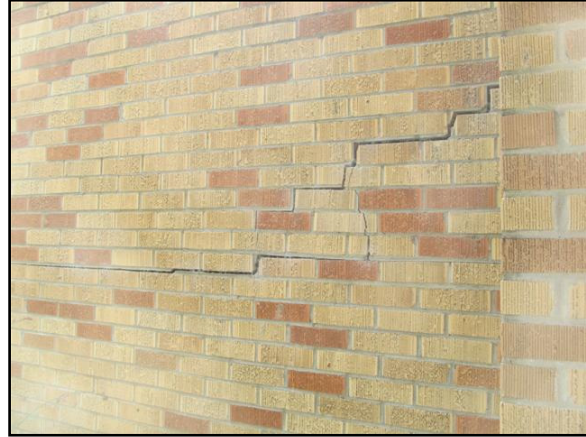
Figures 3 and 4 illustrate the separations in the brick veneer around the front entry doors.

The numerous separations in the brick veneer and concrete masonry are the result of differential foundation movement along the front of the building. The degree of damage would be considered moderate to severe in nature, depending on location. The movement that has occurred has not affected the overall stability of the structure. However, the movement can be expected to continue without proper foundation repair. This could involve installing helical piers around the perimeter followed by raising the foundation to its original position. We anticipate that repair will be required along much of the front (east) exterior wall. This will be followed by pressure grouting underneath the perimeter grade beam and portions of the interior slab to fill in any void spaces created by the lifting procedure.

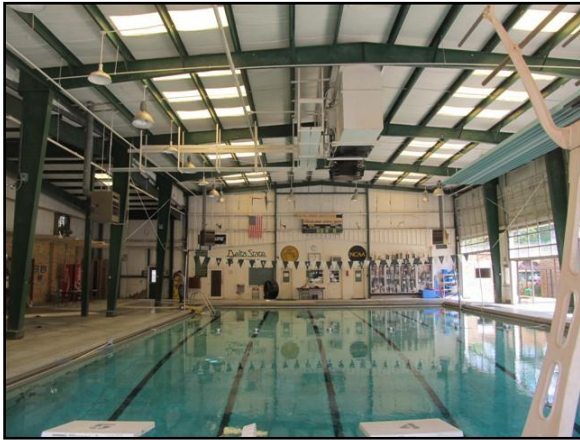
FIGURE 5

Figure 5 shows the primary frames and roof purlins above the swimming pool. Figure 6 shows severe deterioration to the steel cover plate around a column base. Figure 7 illustrates the purlin deterioration at the light panels. Figure 8 shows the north addition roof framing.

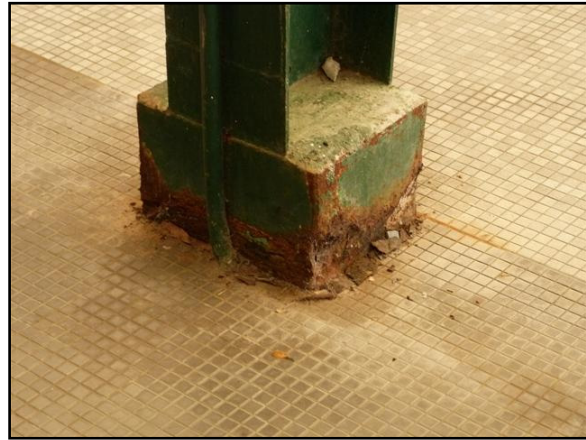
FIGURE 6

The condition of the columns and baseplates is cause for concern. The concrete encasements are not original and their installation was likely prompted by long term deterioration/rust of the previously exposed baseplates. It is probable that the original baseplates, anchor bolts, and lower column sections have experienced further deterioration. Since the column bases are hidden, the extent of structural damage is unknown and warrants further investigation.

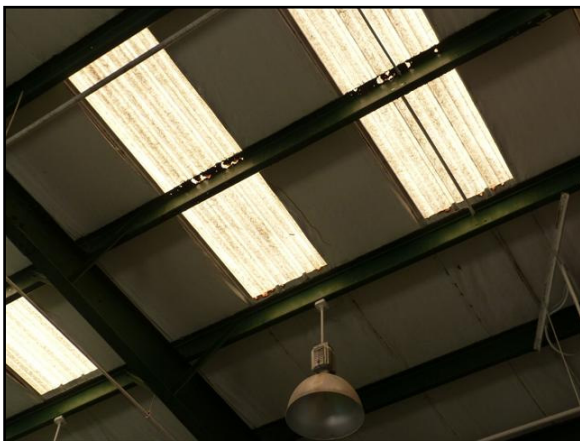
FIGURE 7

Interior observations taken around the pool area found 5 bays of framing with steel support frames spaced at about 21 feet on center. The frames supported roof purlins spaced at approximately 5 feet on center. The baseplates and bottom of the columns were encased with concrete and a steel cover plate. Moderate to severe deterioration of the outer plate was observed at several columns. Examination of the roof purlins found deterioration ranging from moderate to severe in nature. However, the damaged purlins were limited to those directly under translucent roof panels. The remaining purlins away from the roof panels appeared to be undamaged with only minor surface rust/deterioration. Examination of the north addition found comparable but less severe deterioration of the roof purlins around translucent panels.
